Wisconsin Department of Transportation
Determination of Eligibility Short Form for Bridges

Property Name(s): Black River Bridge
Address/Location: CTH G over the Black River
City & County: City of Greenwood, Clark County Zip Code: 54437
Town: T26/27N Range: R2W Section: S3/34
Date of Construction: 1938

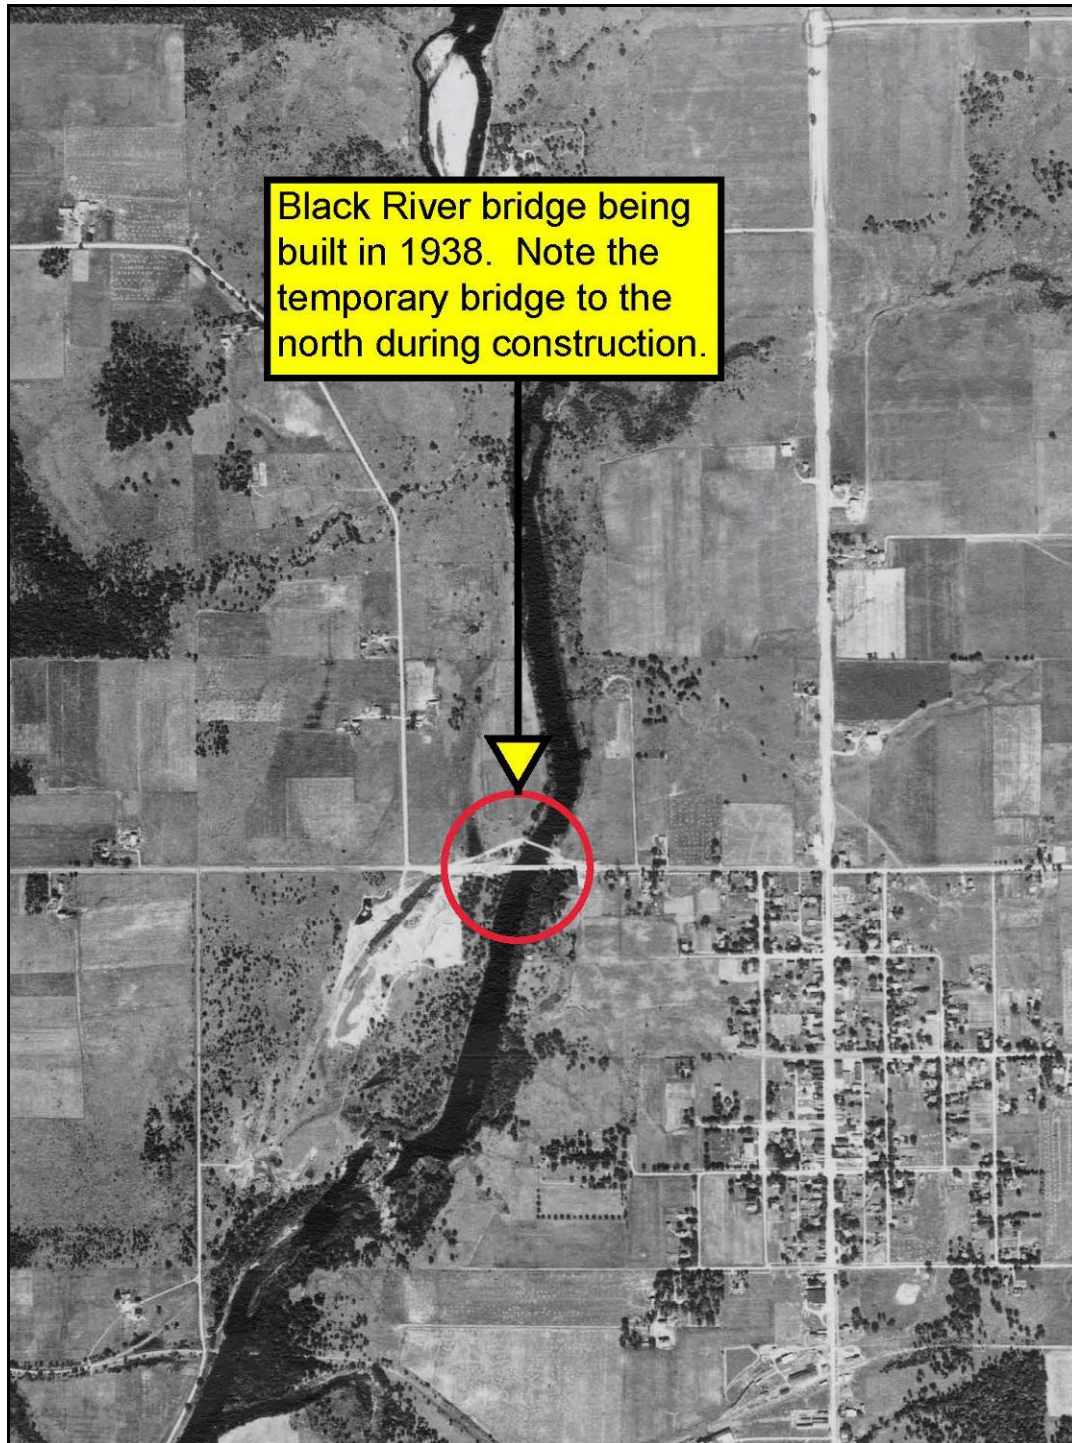
Figure 2: Aerial image adapted from Wisconsin Aerial Image Finder, Image #BHO-5-36, 18 August 1938, Viewed on 15 September 2021 at <http://maps.sco.wisc.edu/WHAOFinder/>.

A bridge across the Black River was situated at this location in 1880 (see Figure 3, page 5). The nature of that structure, as well as the number of successors it may have had, is uncertain. What is known is that the current bridge was constructed in 1938 at the same place, as illustrated in Figure 2, page 4.

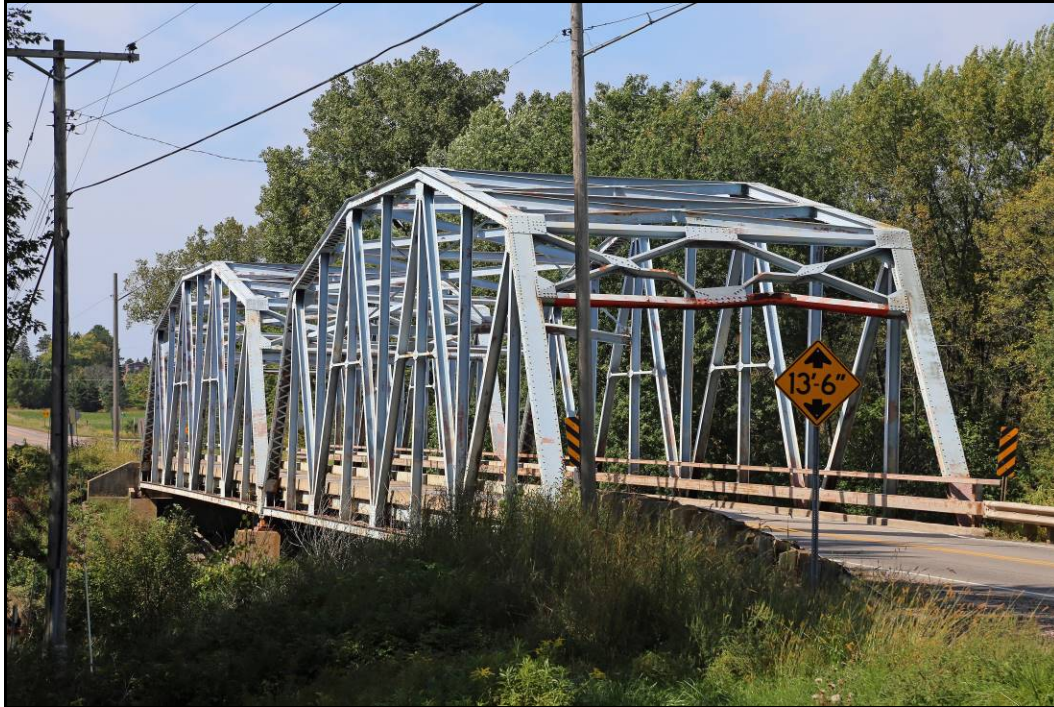
Figure 4: AHI #243375. View to WNW.

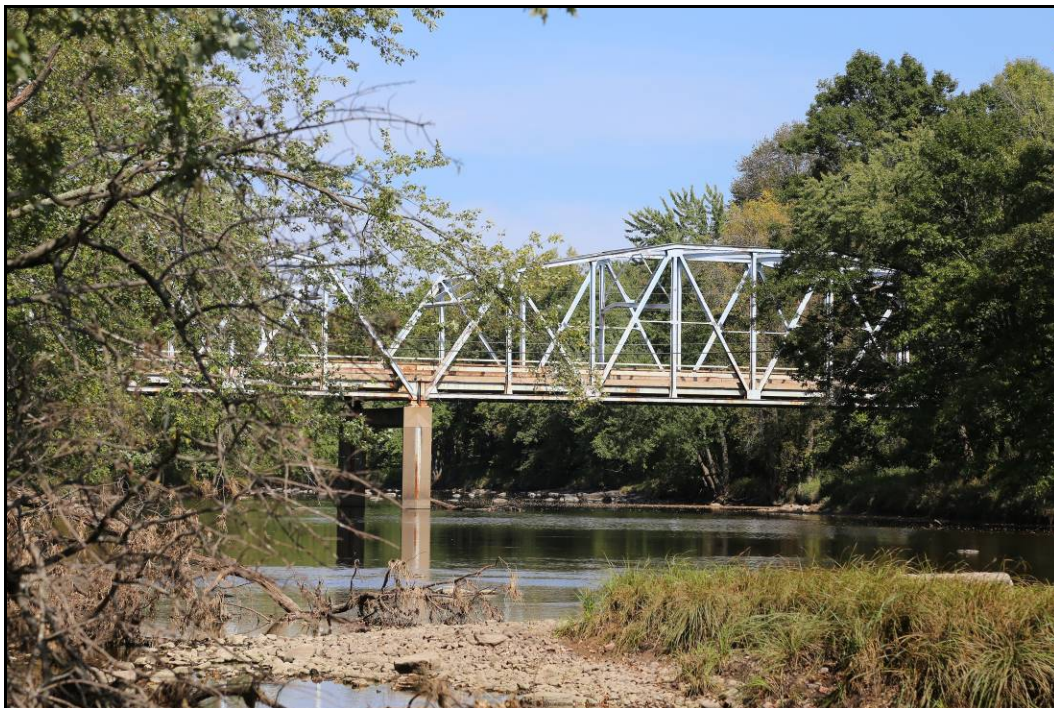
Figure 5: AHI #243375. View to NNE

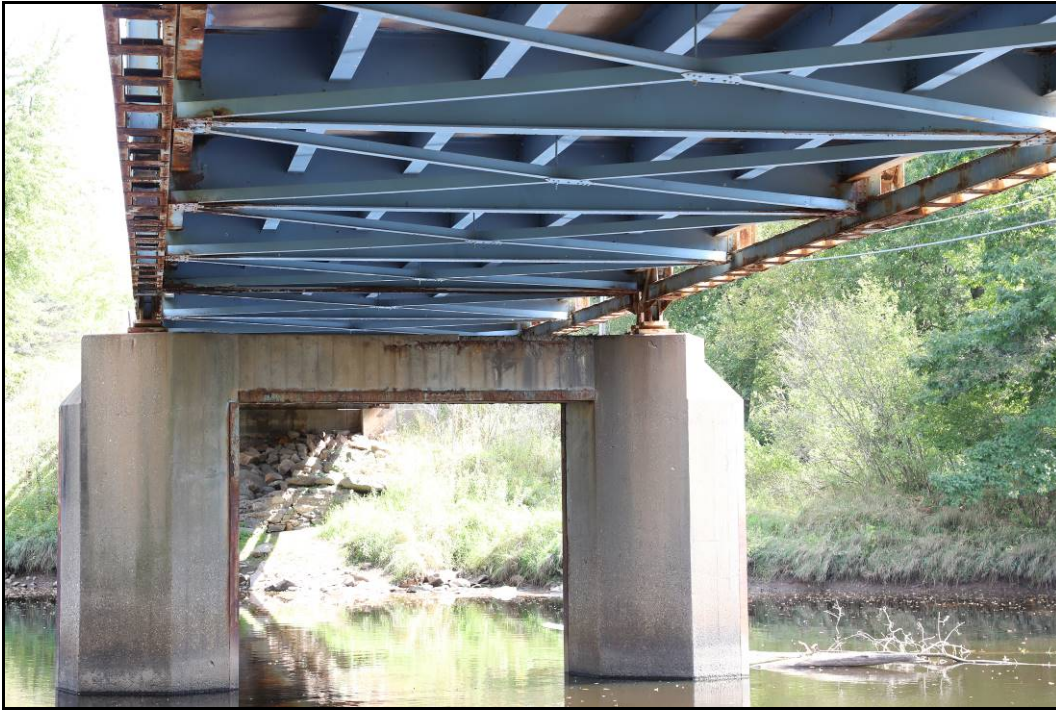
Figure 6: AHI #243375. View to ESE. Pier, deck beams, floor beams and stringers.

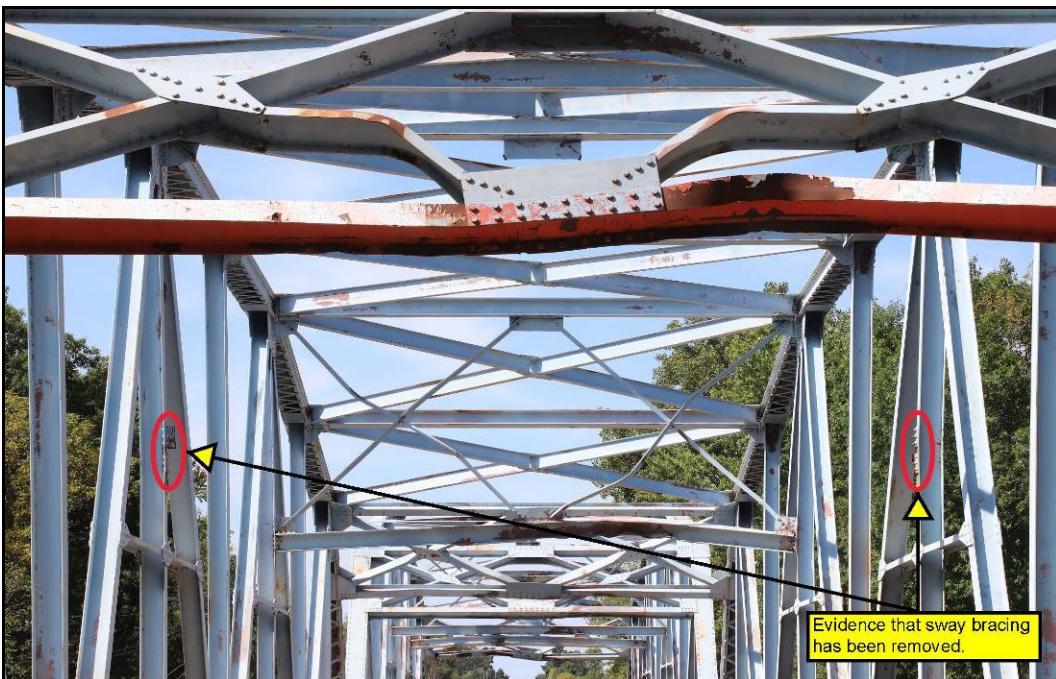
Figure 7: Note the loss of a complete sway bracing component in the easternmost span, as well as evidence of many significant hits to both portal and sway bracing elements.
